## **AIRCRAFT APPRAISAL REPORT**

**Model:** 414A - Chancellor

**Serial No:** 414A-XXXX

**Reg. No.:** N12345

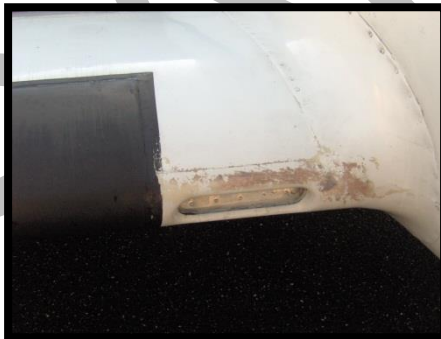
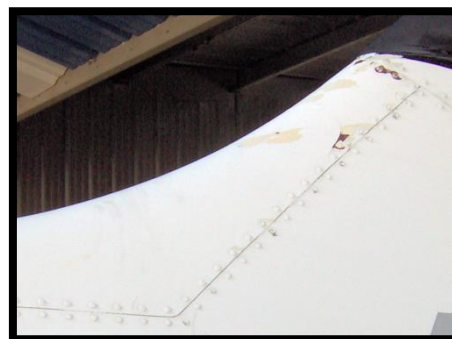
**Comments On Visual Inspection:** At the time of the examination, the aircraft showed no dents, dings or deformations on the leading edges and there were no obvious signs of corrosion. No unusual puckering or pulling was observed around rivets and all rivet lines were straight. Some heavy abrasion was observed on the short wing next to the fuselage which is typical for this type of aircraft and its use. In addition, some minor cracks and breakage were observed in several pieces of the fiberglass trim and panels. The imperfections were observed on closer examination and did not detract from the overall appearance of the aircraft and these issues should be fairly straightforward to replace or correct. Some waviness was also observed in both of the aircraft's ailerons which was later found to be a result of reskinning (see Damage History later in this report). The left oleo strut showed minor leakage and both main tires are serviceable but showing wear and will need to be replaced soon.

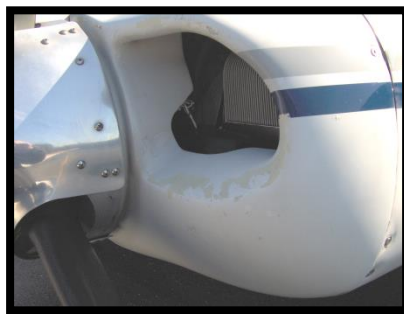
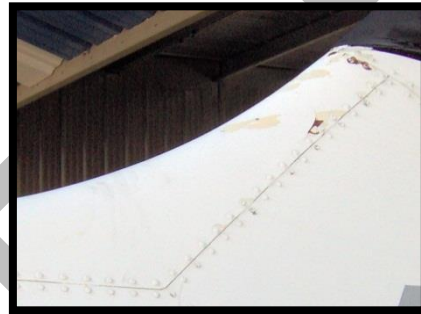
**Comments:** At the time of the examination, the paint had a glossy appearance and was generally adhering well to the airframe. All accent lines are crisp and clean. No pooling, sagging or running was observed and there were no major areas of peeling, chipping or overspray. Several areas on the short wing showed abrasion and chipping and the cowling area showed some peeling/chipping as well. However these areas could be easily touched up. They did not significantly detract from the overall appearance of the aircraft. There is no record in the log book entries that this aircraft has ever been repainted

The paint appears to be original as there is no entry in the log books indicating that the aircraft was repainted. The paint is generally adhering well to the airframe although some wear is showing on the cowling, tail and short wing area. It continues to have a good shine.

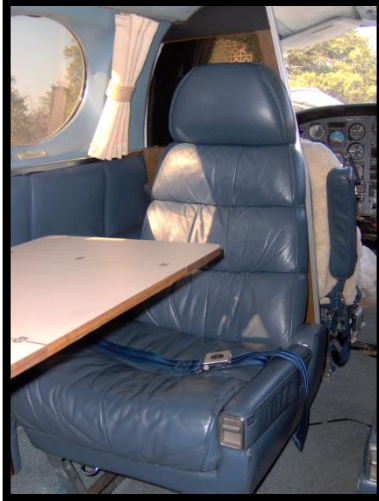
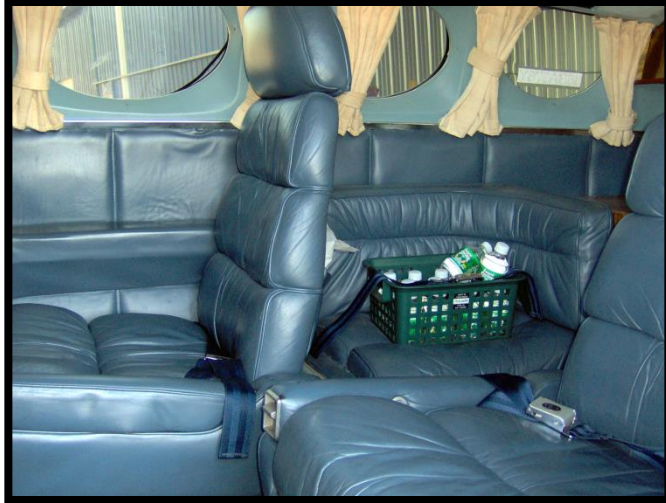
**Comments:** At the time of the examination, the interior was generally clean. The headliner, side panels, upholstery and carpet showed no rips or tears. Overall, all stitching was tight and straight. The side panels were coming loose from the chrome trim and some wear was noted on the upholstery corners from normal use but these items did not detract from the overall appearance of the interior. The carpet was in serviceable condition and showed very little wear. The windows were clean and clear and no cracking, crazing or haziness was observed. There was no sign of water leakage around the doors or windows or anywhere inside the aircraft.

The interior also provides a good first impression. The blue leather seats appear very comfortable and the overall interior of the aircraft is clean. No rips or tears were evident. The carpet showed no soiling and there were no areas of heavy wear. The fold away tables showed no scratches, gouges or scrapes.

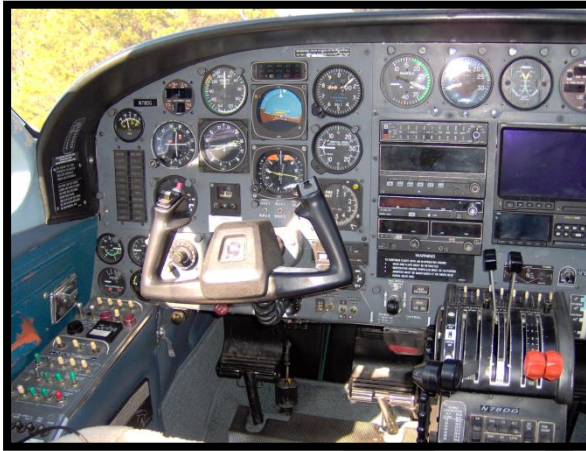
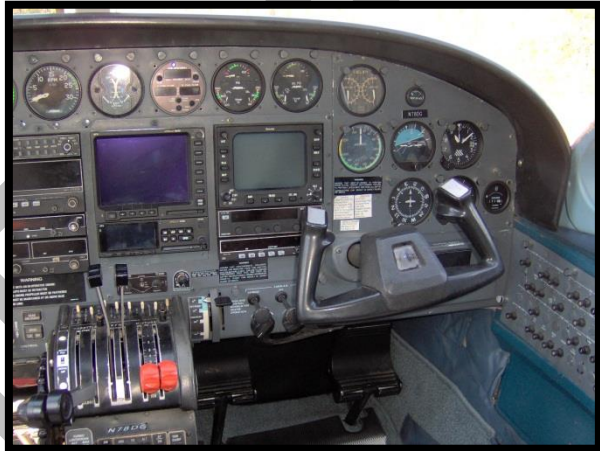
**Comments:** All instruments were arranged in a logical configuration and all instrument glass and displays were clean and clear. The previous static/altimeter check is dated 12/14/04.
