# Sample Report

# Aircraft Appraisal Report

Raytheon Aircraft Company Hawker 800XP

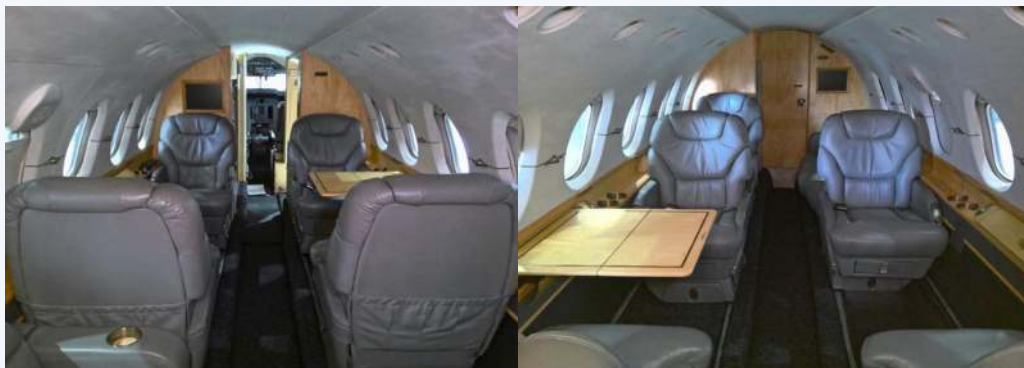
Forward View of Cabin • Aft View of Cabin

At the time of the field visit, the headliner was clean and in serviceable condition. No soiling, rips or tears were observed. The sidepanels were also clean and in serviceable condition. No areas of heavy wear, rips, tears or soiling were observed. The leather upholstery was clean and in serviceable condition and all stitching appeared to be tight and straight. No rips, tears, soiling or areas of heavy/excessive wear were observed. The carpet was generally clean and in serviceable condition although some light soiling was noted that would be consistent with the current maintenance efforts. No rips or tears were observed. The wood paneling was glossy and in serviceable condition. No cracks, scratches, chipping or breakage of the material was noted.

All windows were clean and clear, no cracking, crazing or haziness was observed.

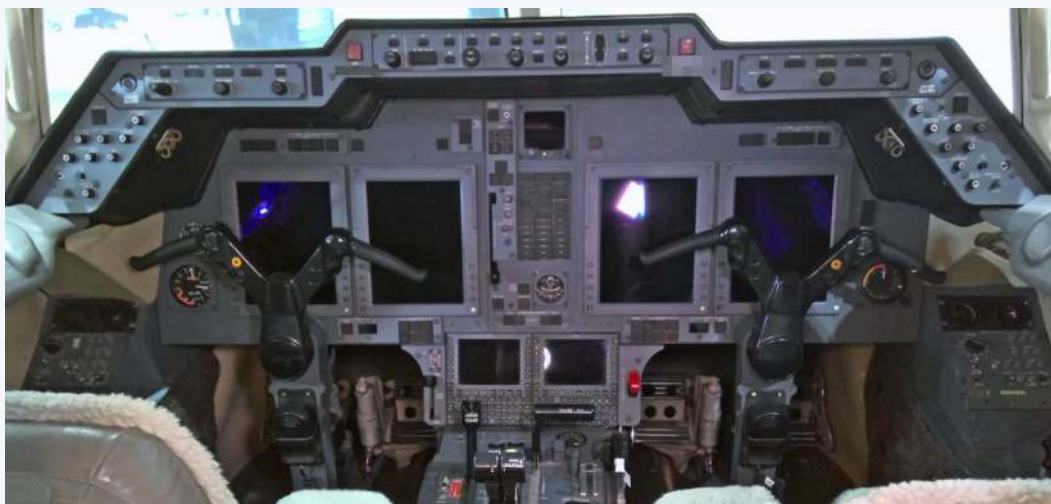
Cockpit Instrument Panel

| Panel Condition | Good |
| Overall Condition of Avionics | Average |

No equipment list was found for this aircraft at the time of the field visit. As a result, the avionics equipment shown in this report is taken from an on-site examination of the aircraft, logbook entries and CAMP Report. It is believed to be reasonably accurate, but errors may exist. Plane Data, Inc. reserves the right to update this report if more reliable information is made available.

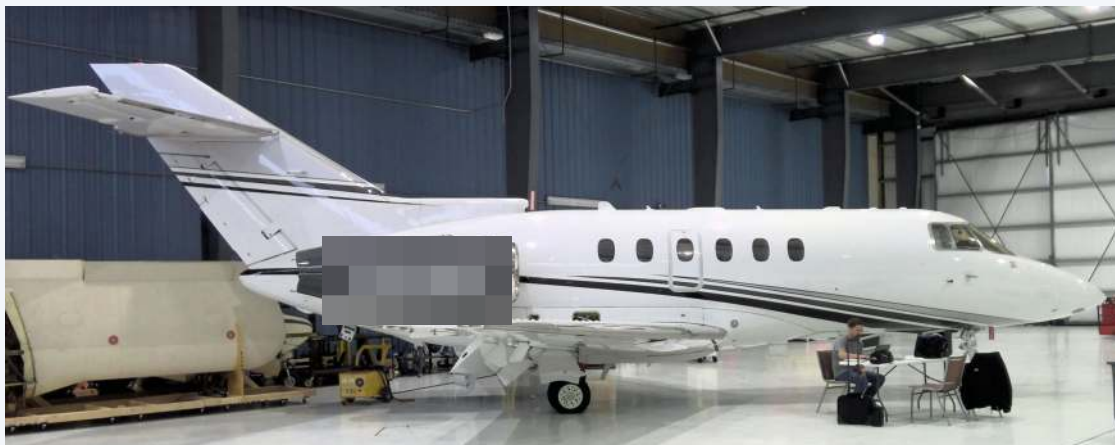
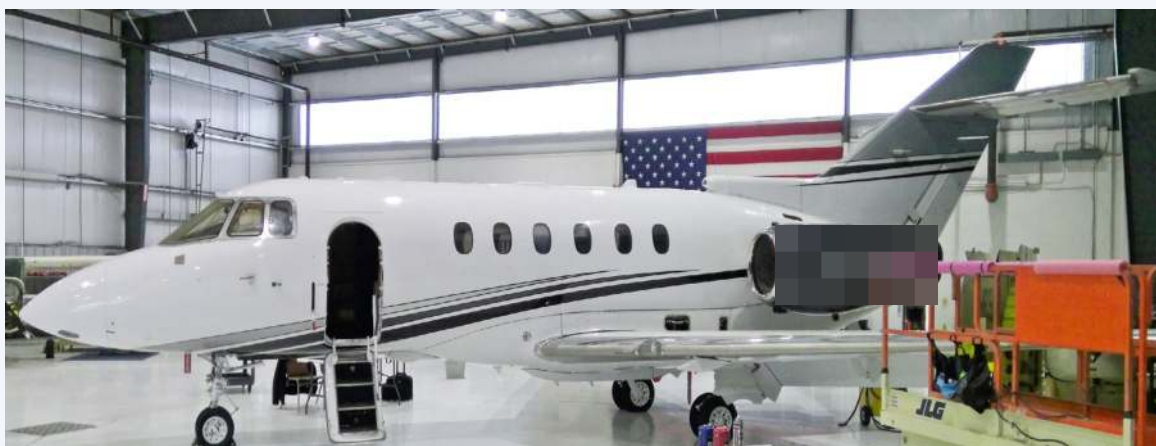
Exterior — Hangar

The exterior of the aircraft showed well and provided a positive first impression. The airframe itself showed no blemishes other than some minor surface corrosion on a few screw heads. There was no indication of repairs from a past damage event and none noted in the logbook entries or FAA/NTSB records. Furthermore, the paint had a wet, glossy appearance and was adhering to the airframe. There were no noticeable areas of touch-up and no sign of chipping or peeling of the paint. No running, pooling or sagging of the paint was observed. Accent lines were crisp and clean. Overall, the application of the paint was professional in nature.

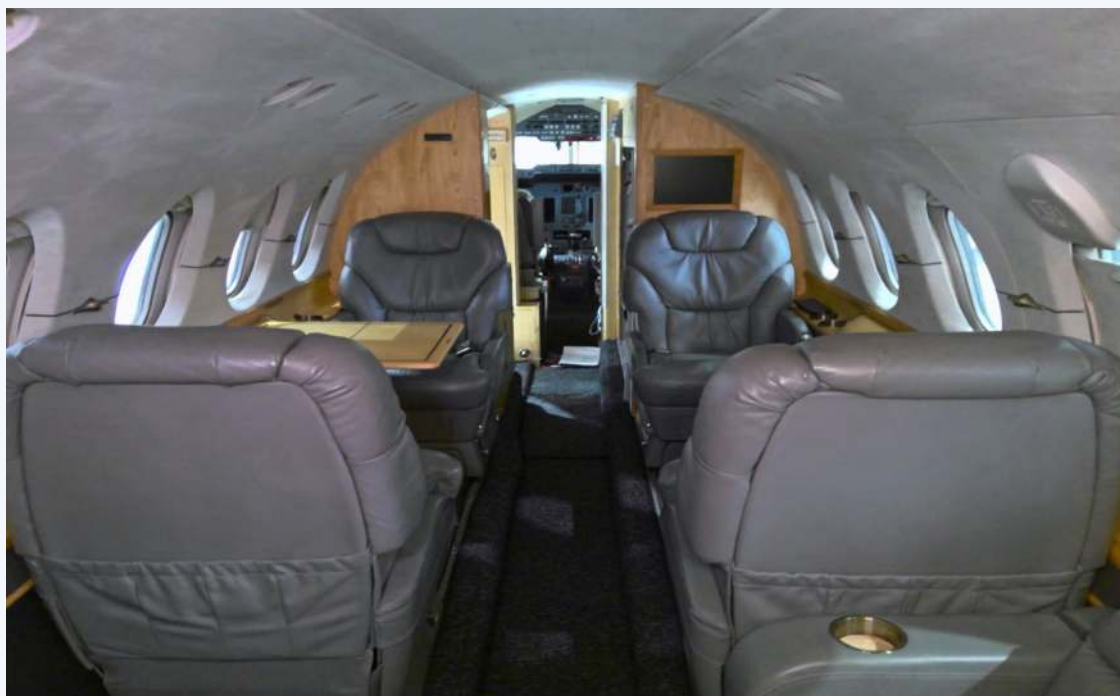
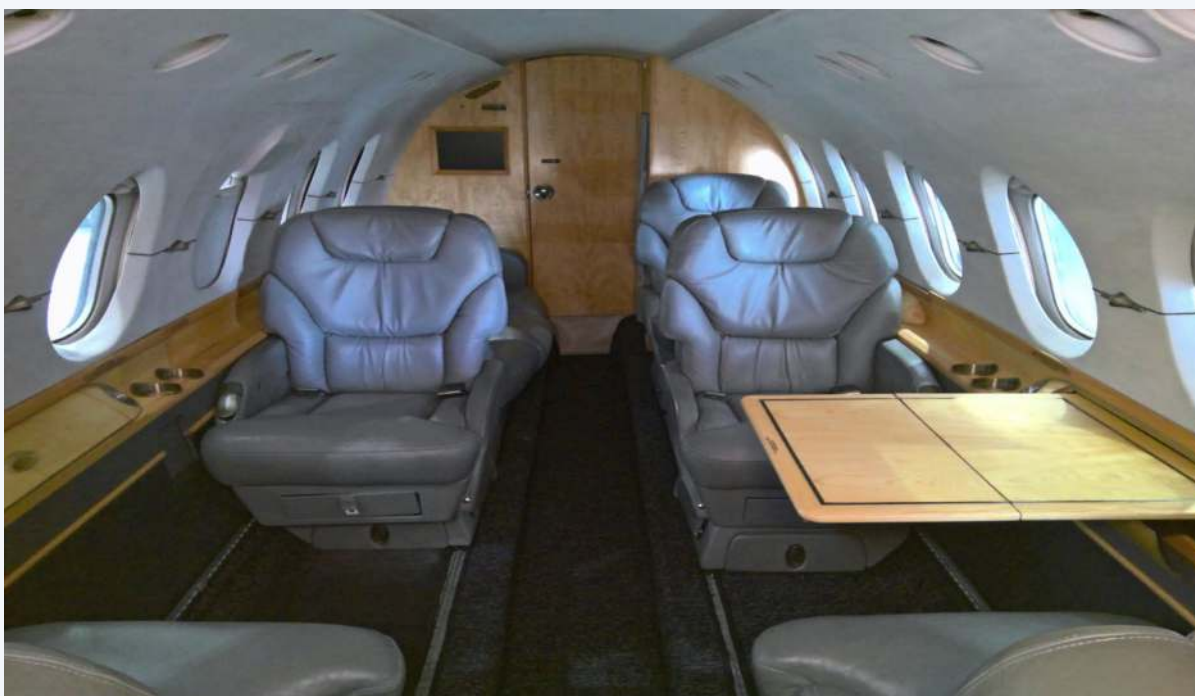
Cabin — Forward

The interior was generally clean and in serviceable condition. The leather upholstery showed no rips, tears or soiling and the stitching was tight and straight. The carpet showed light soiling but was in serviceable condition. No stains or noticeable problem areas were noted anywhere in the interior.
