<u>Plane Data, Inc.</u> AIRCRAFT APPRAISAL REPORT

Aircraft Identification

Make: CESSNA AIRCRAFT COMPANYModel: 414A - ChancellorSerial No: 414A-XXXXReg. No.: N12345Yr. Mfg.: 19XX

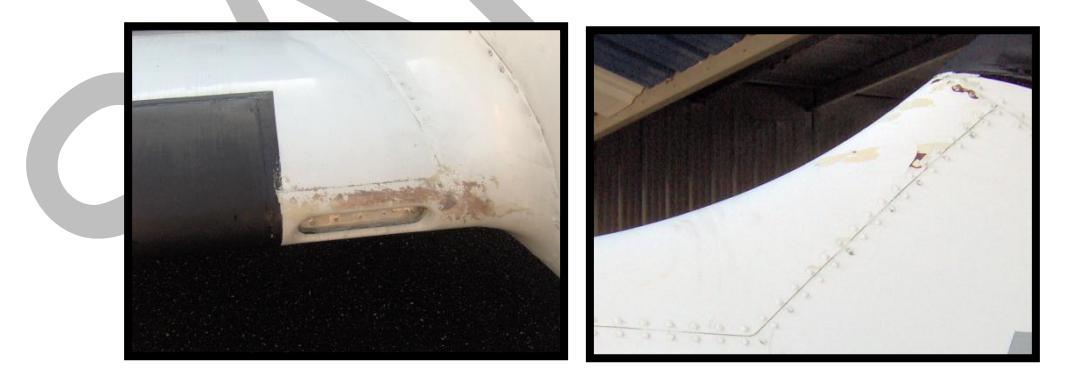
Comments On Visual Inspection: At the time of the examination, the aircraft showed no dents, dings or deformations on the leading edges and there were no obvious signs of corrosion. No unusual puckering or pulling was observed around rivets and all rivet lines were straight. Some heavy abrasion was observed on the short wing next to the fuselage which is typical for this type of aircraft and its use. In addition, some minor cracks and breakage were observed in several pieces of the fiberglass trim and panels. The imperfections were observed on closer examination and did not detract from the overall appearance of the aircraft and these issues should be fairly straightforward to replace or correct. Some waviness was also observed in both of the aircraft's ailerons which was later found to be a result of reskinning (see Damage History later in this report). The left oleo strut showed minor leakage and both main tires are serviceable but showing wear and will need to be replaced soon.

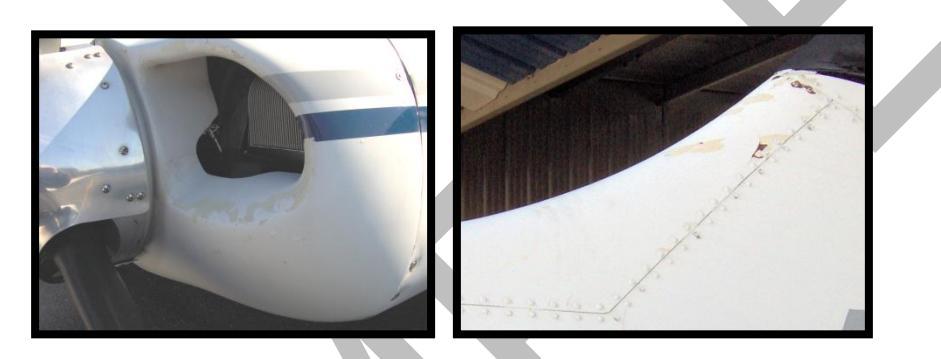
Comments: At the time of the examination, the paint had a glossy appearance and was generally adhering well to the airframe. All accent lines are crisp and clean. No pooling, sagging or running was observed and there were no major areas of peeling, chipping or overspray. Several areas on the short wing showed abrasion and chipping and the cowling area showed some peeling/chipping as well. However these areas could be easily touched up. They did not significantly detract from the overall appearance of the aircraft. There is no record in the log book entries that this aircraft has ever been repainted

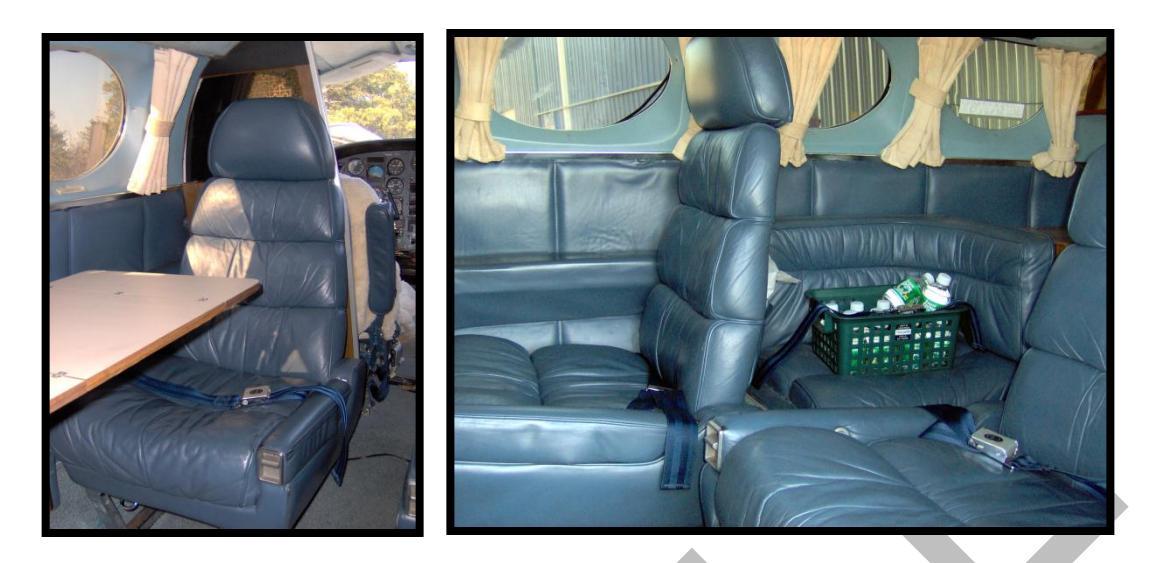
Comments: At the time of the examination, the interior was generally clean. The headliner, side panels, upholstery and carpet showed no rips or tears. Overall, all stitching was tight and straight. The side panels were coming loose from the chrome trim and some wear was noted on the upholstery corners from normal use but these items did not detract from the overall appearance of the interior. The carpet was in serviceable condition and showed very little wear. The windows were clean and clear and no cracking, crazing or haziness was observed. There was no sign of water leakage around the doors or windows or anywhere inside the aircraft.

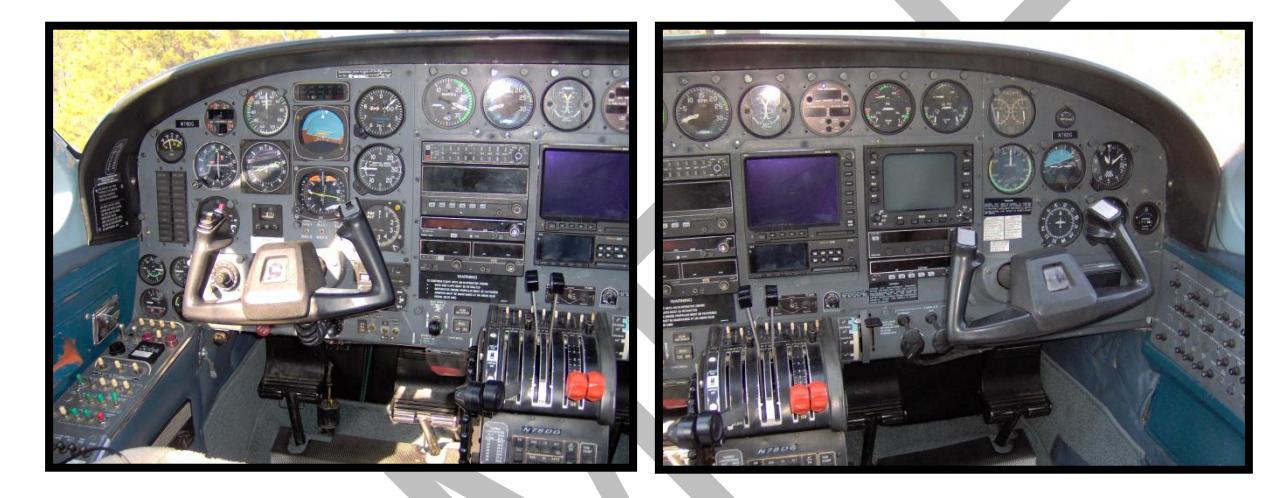
Comments: All instruments were arranged in a logical configuration and all instrument glass and displays were clean and clear. The previous static/altimeter check is dated 12/14/04.
