CERTIFICATIONS
Aircraft Appraisal Report - N12345
Conducted in conformity with the
Uniform Standards Of Professional Appraisal Practice

USPAP AIRCRAFT APPRAISAL REPORT

Make: GULFSTREAM AEROSPACE

Model: G-1159A G III

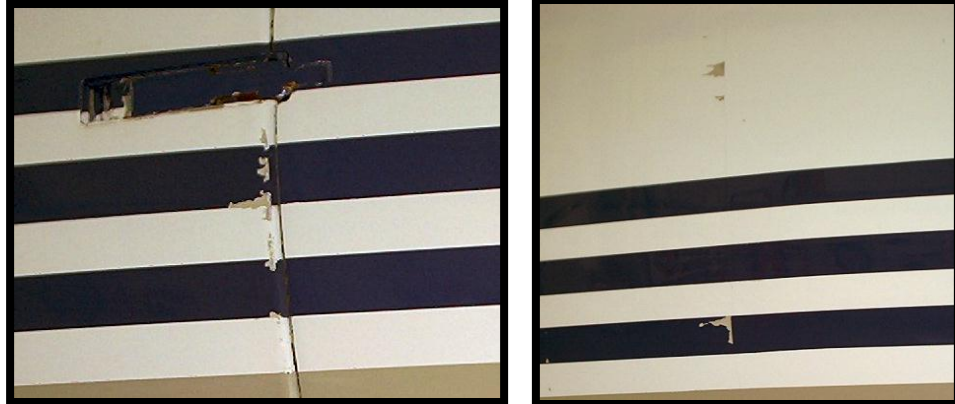
Comments: At the time of the examination, the paint had a wet, glossy appearance and was generally adhering well to the airframe. No areas of pooling or running were observed and there were no major areas of chipping or peeling. Some very minor chipping/peeling was noticed near the radome and could easily be touched up but these areas were noticed on close examination and did not detract from the overall appearance of the aircraft.

The log book entry of 3/31/00 indicates that the aircraft was stripped and painted using Matterhorn White (570-535), Skyline steel (WR-07486), and Teal Blue (WQ-7450).

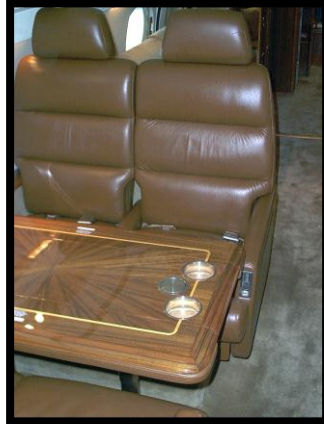
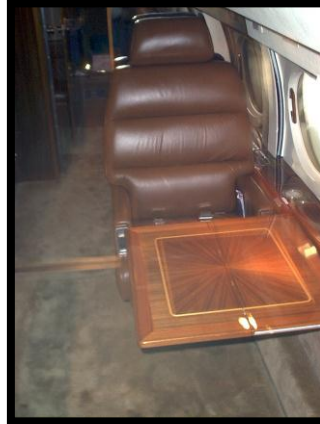
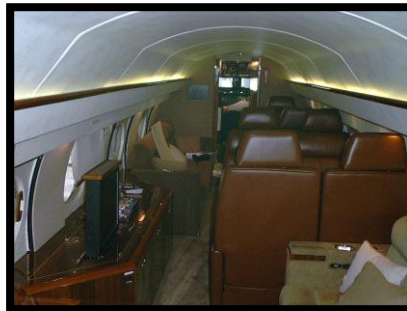
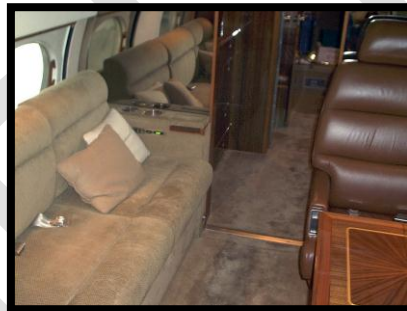
Comments: The interior was generally clean and in serviceable condition. The headliner showed no rips, tears or staining. The cabin area seats 15. Seven (7) individuals can be accommodated in individual leather seats and eight (8) can be seated in the two divans. The leather upholstery was in serviceable condition and all stitching was tight and straight and no rips or tears were observed on the individual seats although some very minor creasing was observed in the leather. The condition of the leather made the upholstery look almost new. The divans were cloth covered and in serviceable condition. One small worn area was observed on the lower right corner on the front divan. The rear divan shows some wear on the front portion of the lower cushions that is consistent with normal use. All stitching was straight and tight. The carpet showed some matting and wear but was serviceable and holding up very well. The cabinetry and paneling was serviceable and showed well in that it had a wet glossy appearance at a distance but there were several areas where the finish was cracked. Although it does not seriously detract from the interior's initial overall appearance, the cabinetry and paneling will need to be refinished at some point in the future.

The windows were generally clean and clear and did not show any scratching, crazing or cracking. No water stains were found inside the aircraft or around doors or windows.

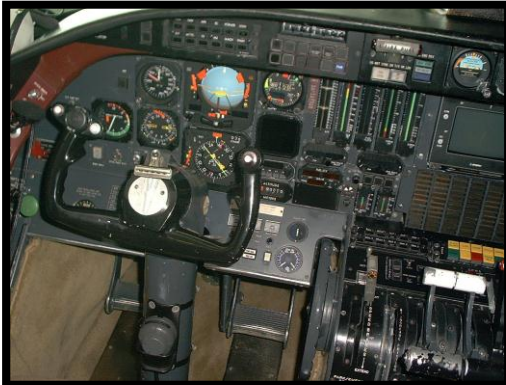
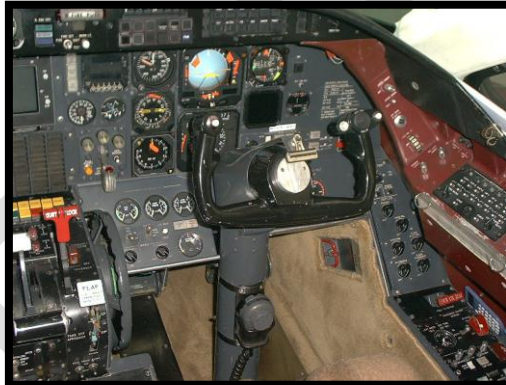
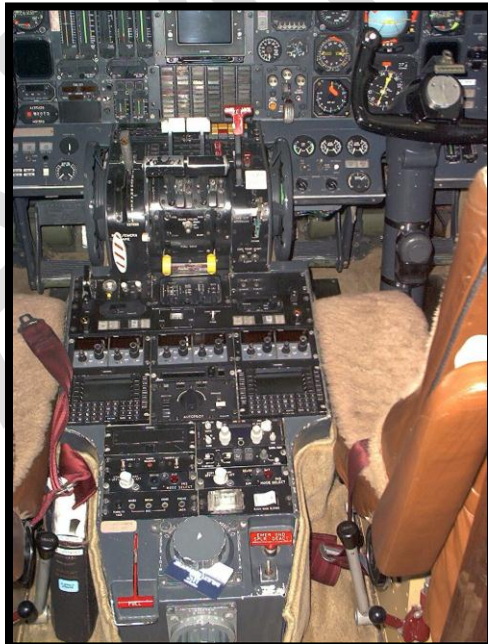
Comments: All instruments are arranged in a logical manner and all instrument glass/displays are clean and clear. The last recorded static/altimeter check was performed on 10/30/03.
